# U-6A / NU-1B Technical Support Contract

## Aircraft Inspection Report

December 19, 2003

Document Number: 2003 NU-1B 0001

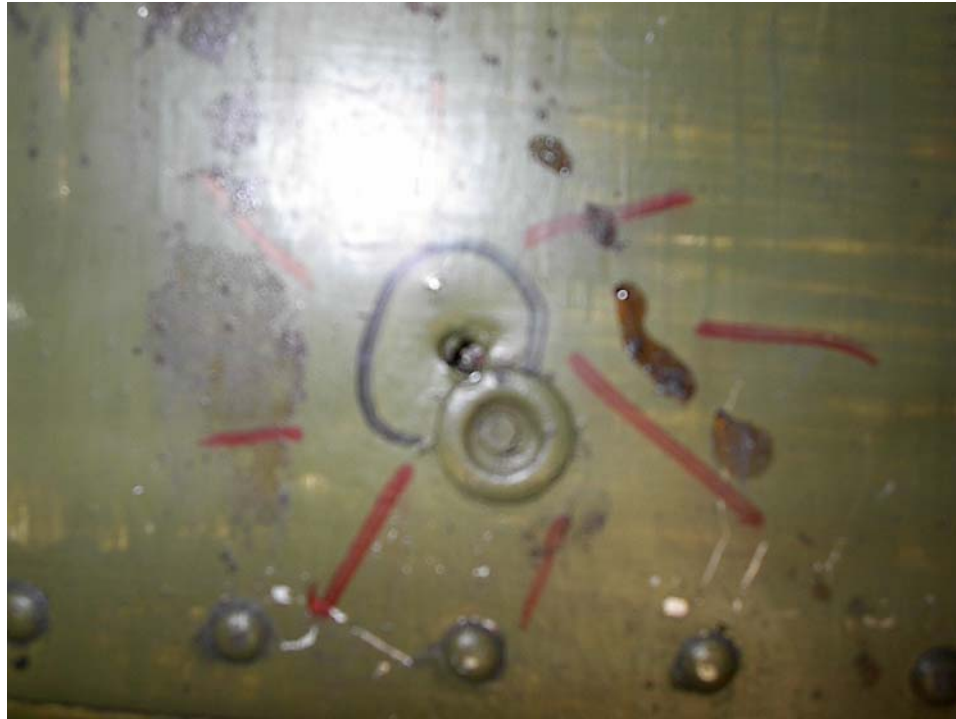
**5.4.1.27. Cabin sub floor #2 has hole in LH AFT skin next button snap.**

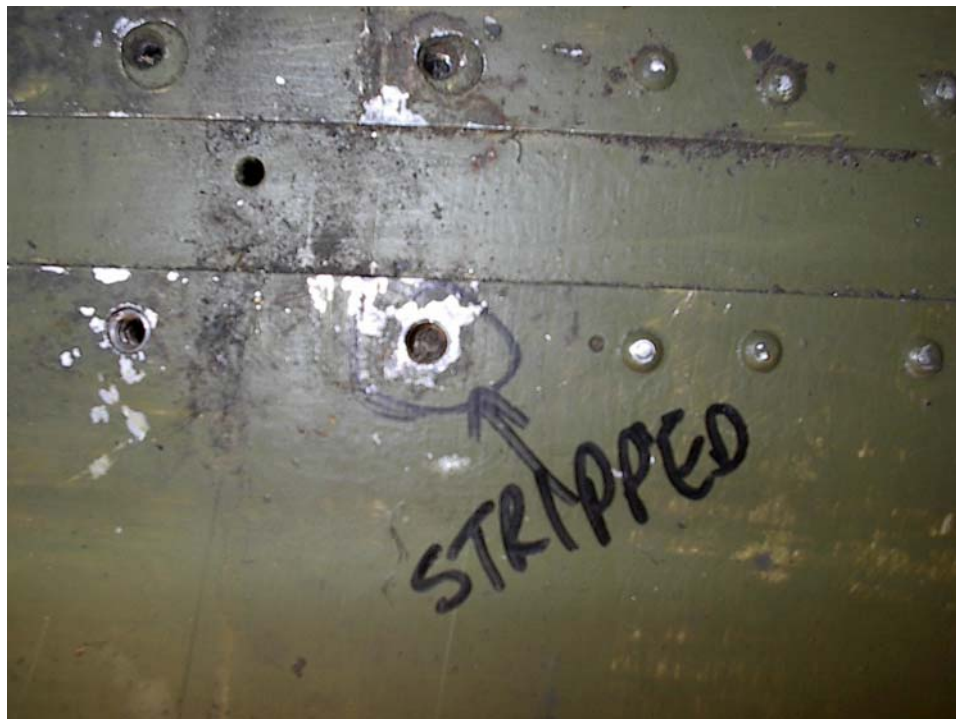
**5.4.1.28. Cabin sub floor #4 has 1 stripped anchor nut at forward LH corner**

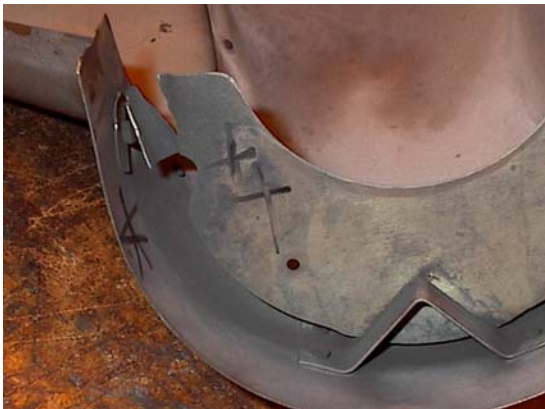
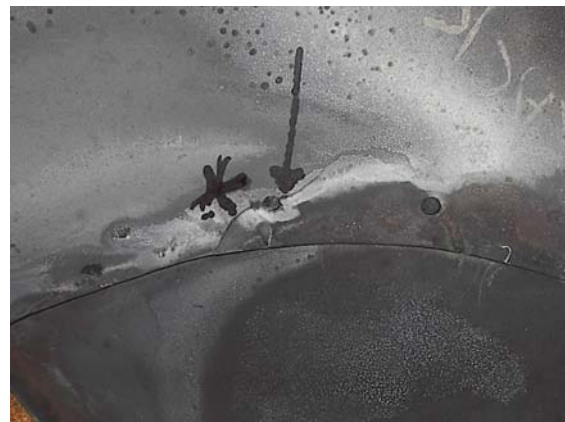
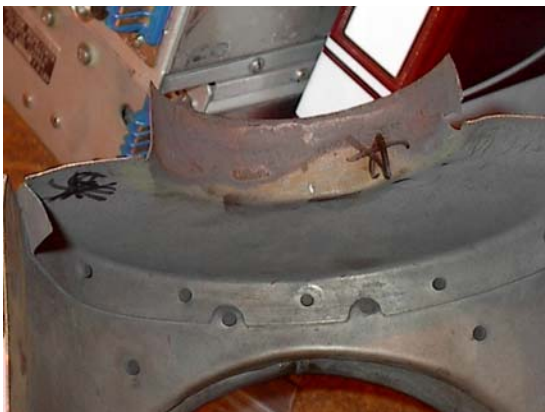
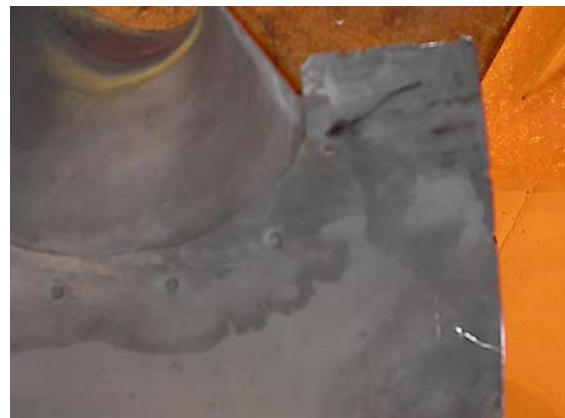
##### 5.4.4.1. **Many cracks, tears, etc. found on all heat muff baffles.**
